A Wireless, Multi-Parameter Method and Device for Monitoring the Condition of Pipelines and Mechanical Structures

Eugene B. Silverman, PhD
Berkeley Springs Instruments
14901 Uhl Hwy, SE
Cumberland, Maryland 21502, USA
gene.silverman@bsisentry.com

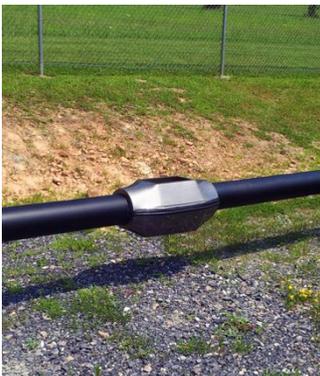
Figure 1. Ultrasound array with solar collector integrated into housing.

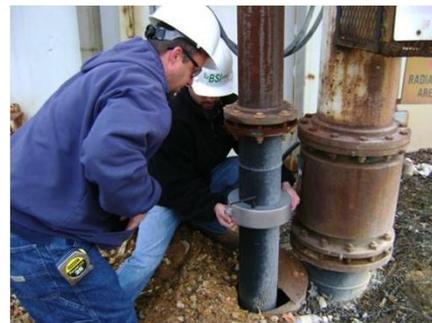
Figure 2. Installation of original array/cover on a vertical slurry line adjacent to a flange.

and government pipeline integrity monitoring and protection objectives. The system discussed in this paper is a multi-parameter condition monitoring system that provides real-time monitoring of pipelines and pipeline components using an array of ultrasound transducers (for tracking pipe wall thickness) combined with a sensor suite that tracks vibrations, temperature/humidity and local shock events. The system can also be configured to measure product velocity, sediment accumulation and multi-phase fluid flow. Figure 1 provides a photograph of the system configured for solar power and installed on a straight pipe without transitions. Figure 2 is a photograph of a line-powered installation positioned adjacent to a flange.
